Manhole Inspection Summary

Manhole # S27S__010MH

Location Address: **1539 Wicomico St**

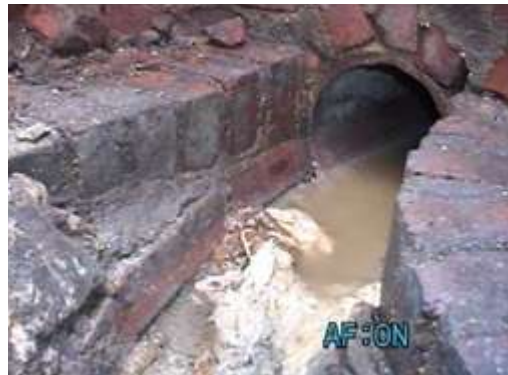
Defect 5

debris in channel

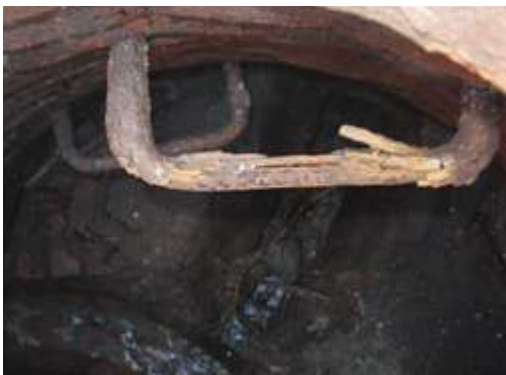
Defect 3

Count: **2** Missing: **0** ☒ **Corroded**

corroded rungs

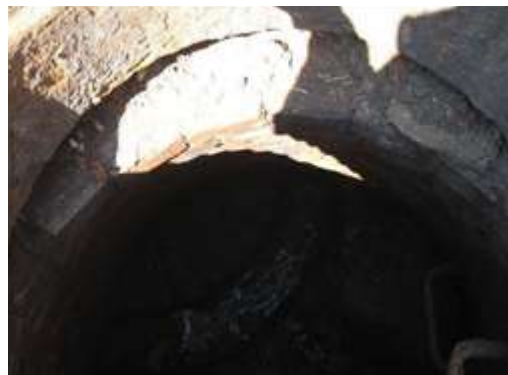
Defect 4

Condition: ☐ Sound ☐ Cracked ☐ Root Intrusion ☐ Loose Brick ☒ **Deteriorated**

Infiltration: ☐ None ☒ **Joint** ☐ Cracks ☒ **Mortar** ☐ Roots ☐ Wall

deteriorated chimney, signs of infiltration

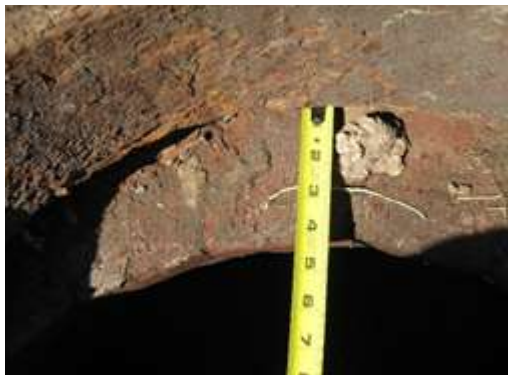
Offset: **4** (in.)

Condition: ☐ Sound ☐ Cracked ☒ **Leaks**

offset

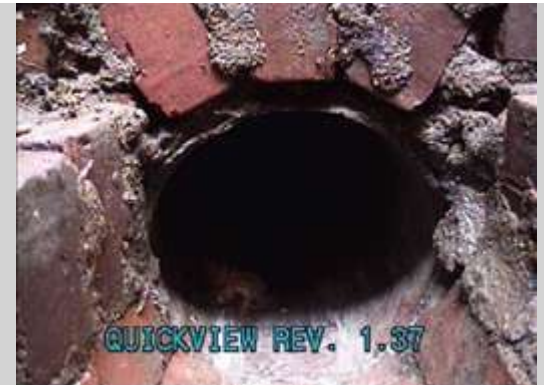
12 O'Clock Outflow

Pipe Height: **8.4** (in.) Rod and Bar (Angled)
Pipe Material: **Clay** ☐ Pipe Lined
Invert Depth: **5.22** (ft.) Flow Characteristics: **Slow**
Deposits: ☒ None ☐ Mud ☐ Grassy ☐ Debris ☐ Grease
Silt Depth: **0** (in.) Deposits Extent:
Infiltration: **None** Pipe Seal Cond: **Sound**

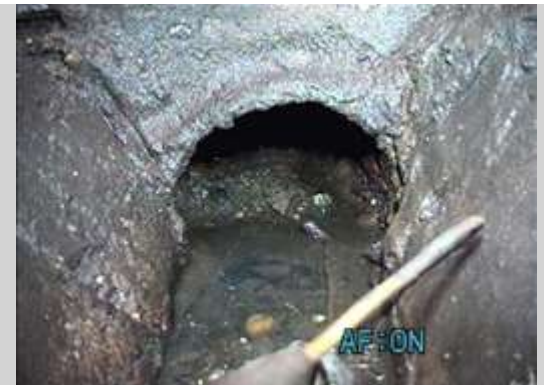
4 O'Clock Inflow

Pipe Height: **6** (in.) Rod and Bar (Angled)
Pipe Material: **Clay** ☐ Pipe Lined
Invert Depth: **5.02** (ft.) Flow Characteristics: **None**
Deposits: ☒ None ☐ Mud ☐ Grassy ☐ Debris ☐ Grease
Silt Depth: **0** (in.) Deposits Extent:
Infiltration: **None** Pipe Seal Cond: **Unknown**

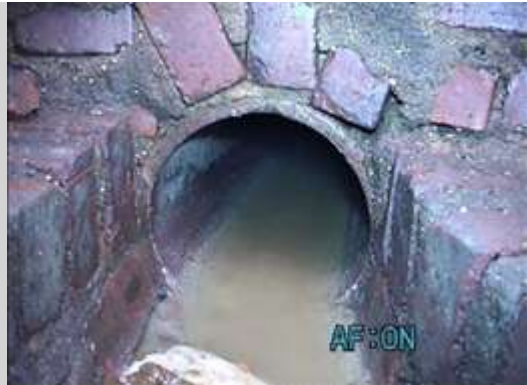
8 O'Clock Inflow

Deposits: ☐ None ☒ **Mud** ☒ **Sludge** ☐ Debris ☐ Grease

Silt Depth: **0.5** (in.) Deposits Extent: **Light**
